Manhole Inspection Summary

Manhole # S19A1_003MH

Location Address: **2056 whistler av**

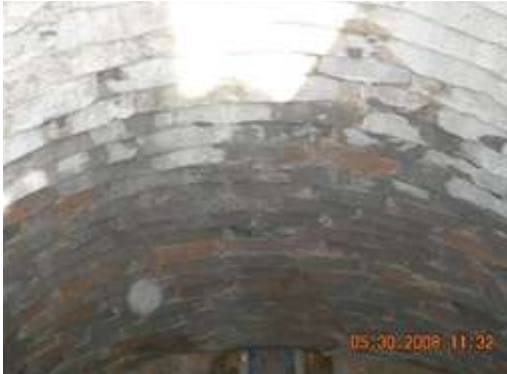
Defect 9

Infiltration: ☐ None ☐ Joint ☐ Cracks ☐ Mortar ☐ Roots ☒ **Wall**

infiltration @ barrel wall

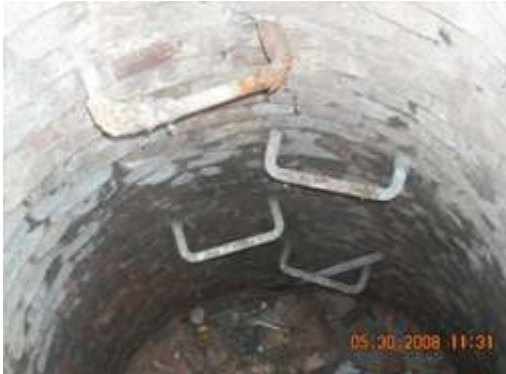
Defect 8

Steps Count: **4** Missing: **0** ☒ **Corroded**

corroded steps

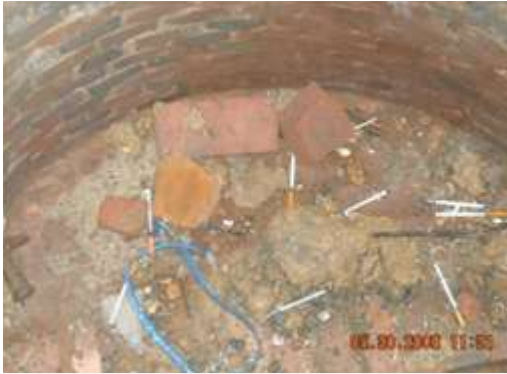
Defect 7

Condition: ☐ Sound ☐ Cracked ☐ Root Intrusion ☐ Deteriorated ☐ Leaks ☒ **Debris**

debris on bench

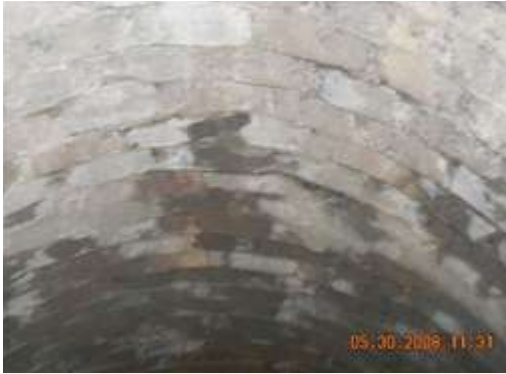
Defect 6

Infiltration: ☐ None ☐ Joint ☐ Cracks ☐ Mortar ☐ Roots ☒ **Wall**

infiltration @ corbel wall

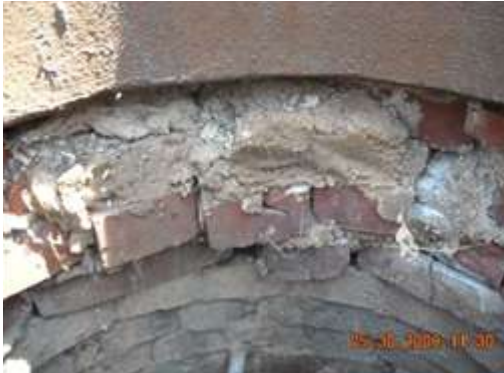
Defect 5

Condition: ☐ Sound ☐ Cracked ☐ Root Intrusion ☒ **Loose Brick** ☒ **Deteriorated**

deteriorated chimney

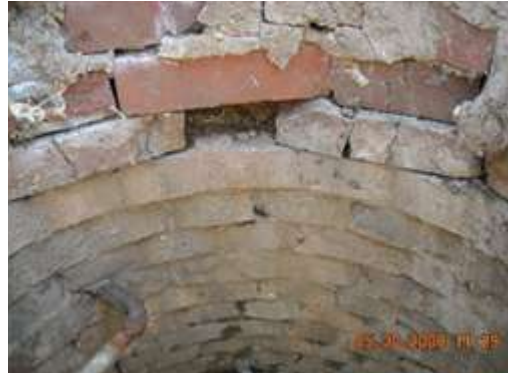
Defect 4

Condition: ☐ Sound ☒ **Cracked** ☐ Root Intrusion ☒ **Loose Brick** ☐ Deteriorated

loose/missing corbel brick

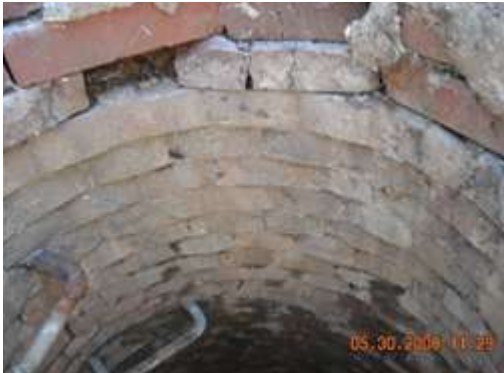
Defect 3

cracked corbel brick

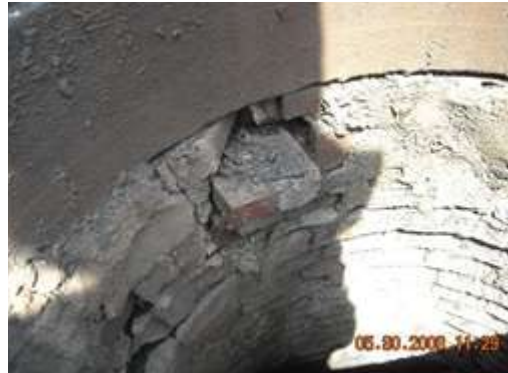
Defect 2

Frame Offset: **1** (in.) Condition: ☐ Sound ☐ Cracked ☒ **Leaks**

loose chimney brick, frame leaks-sheeting evidence

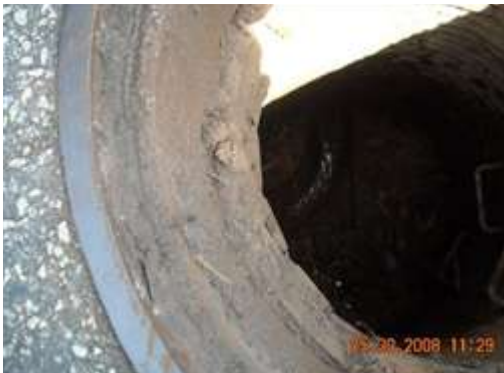
Defect 1

frame offset

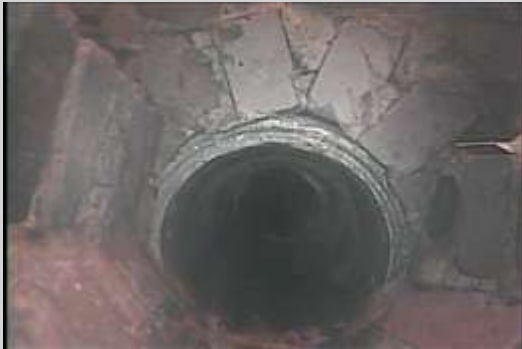
12 O'Clock Outflow

Pipe Height: **8.4** (in.) Rod and Bar (Angled)
Pipe Material: **Clay** ☐ Pipe Lined
Invert Depth: **8.86** (ft.) Flow Characteristics: **Slow**
Deposits: ☒ None ☐ Mud ☐ Sludge ☐ Debris ☐ Grease
Silt Depth: **0** (in.) Deposits Extent:
Infiltration: **None** Pipe Seal Cond: **Sound**

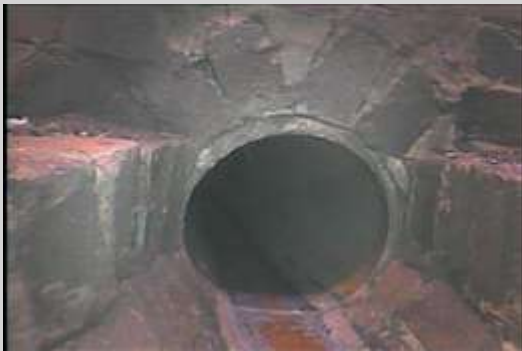
3 O'Clock Inflow

Pipe Height: **8.4** (in.) Rod and Bar (Angled)
Pipe Material: **Clay** ☐ Pipe Lined
Invert Depth: **8.52** (ft.) Flow Characteristics: **Slow**
Deposits: ☒ None ☐ Mud ☐ Sludge ☐ Debris ☐ Grease
Silt Depth: **0** (in.) Deposits Extent:
Infiltration: **None** Pipe Seal Cond: **Sound**
